Mimicking Beavers to Heal Damaged Streams

By Julie Ashmore, Conservation Coordinator, Okanogan Highlands Alliance

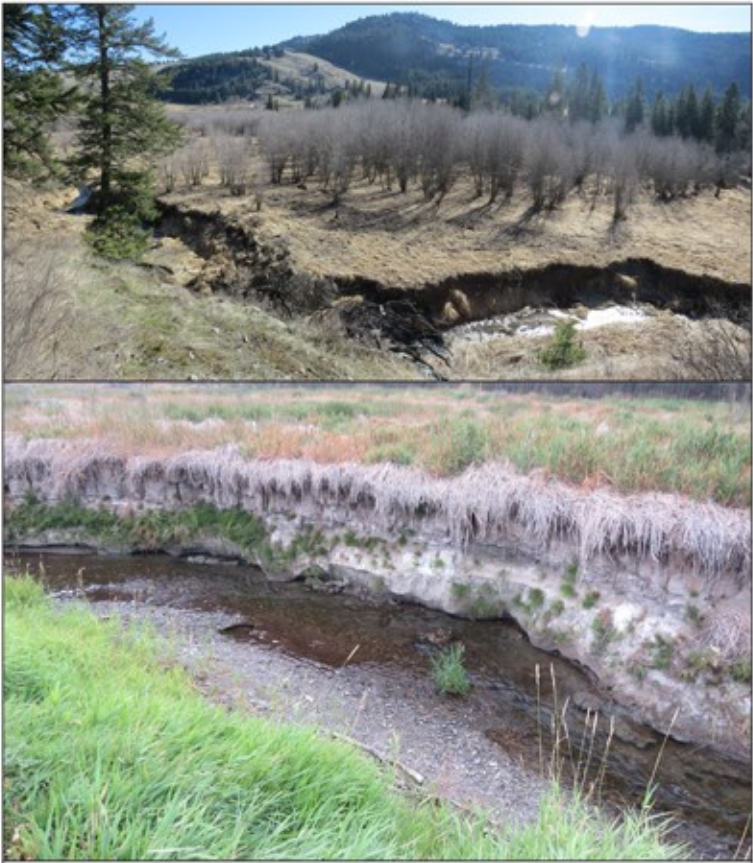
The above photos show the incised channel in the Myers Creek watershed. The streambed has dropped, and as a result, the stream is disconnected from its floodplain.

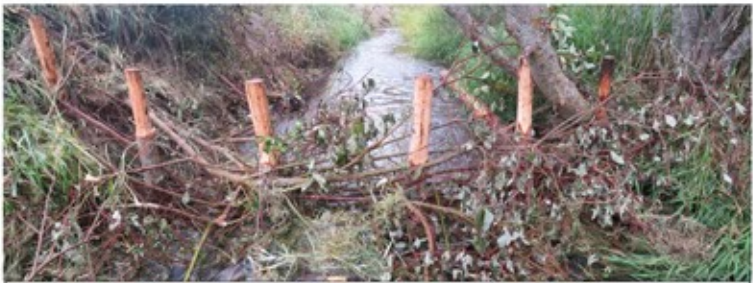
A beaver dam analogue: vertical pilings placed across the stream were woven with live cuttings to slow flows and to provide beavers with a stable starting place for dam building.

The restoration approach mimics beavers by installing “beaver dam analogues” to slowly raise the water table and capture sediment to help build the streambed back up. Establishing riparian plants will help support beaver in the long term.
